## Quarterly Report – Public Page

Project Title: Nonmetallic Joint Quality Assessment

Prepared by: Gas Technology Institute

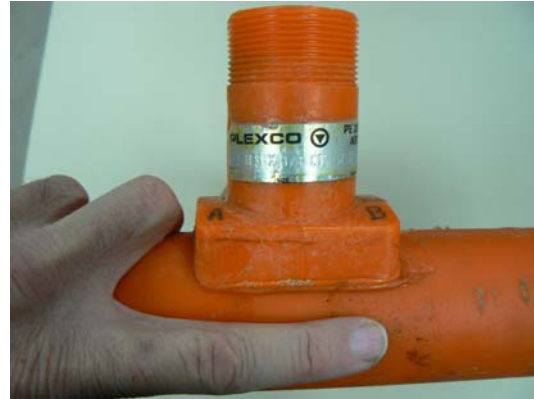
This rectangular base permits relatively easy access for inspecting the fusion area.

As shown in the second figure, some saddle tees have a flat, rectangular base that permits easy access for sensors. A combination of two sensor geometries and scan patterns were developed for such saddle tees. It will be difficult to inspect the entire fusion interface of some other saddle tee geometries.
